# Special Report 84-13

Cold Regions Research &  
Engineering Laboratory

## *Performance of the Allegheny River ice control structure, 1983*

David Deck and Gordon Gooch

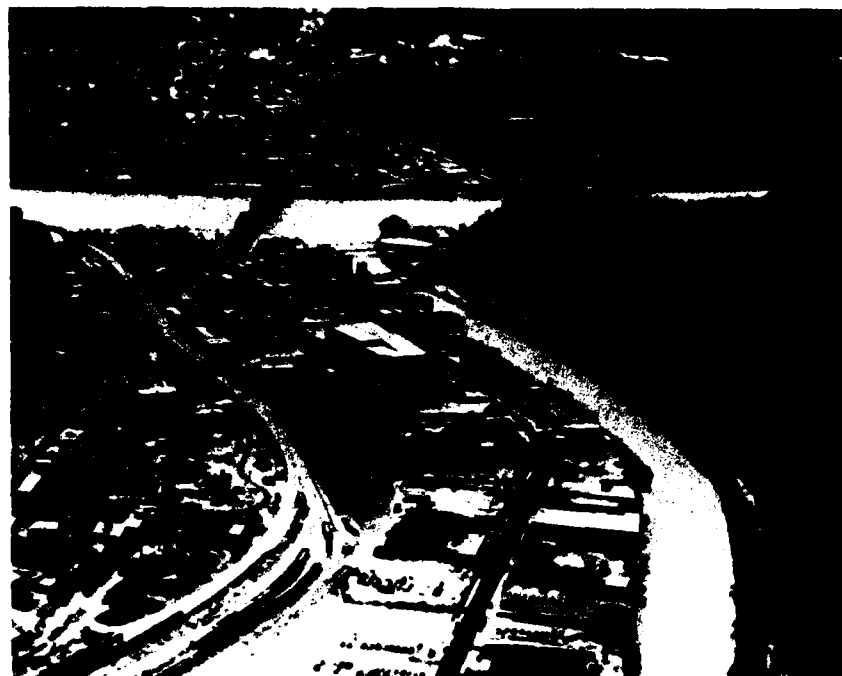
Figure 2. Typical freezeup before ice control structures were built.

The Oil City business district is located on a flood plain at the confluence of Oil Creek and the Allegheny River (Fig. 1). The natural river ice cover begins to accumulate approximately 3.5 km downstream of the city, and a continuous, stable cover can extend as much as 45 km upstream on the Allegheny River and 25 km on Oil Creek. The ice on both the creek and the river consists almost entirely of frazil ice. The freezeup jam is a hanging frazil dam that restricts up to 60% of the cross-sectional flow area. This accumulation is more than 5 m thick in some locations. Figure 2 shows a typical January or February scene at Oil City.

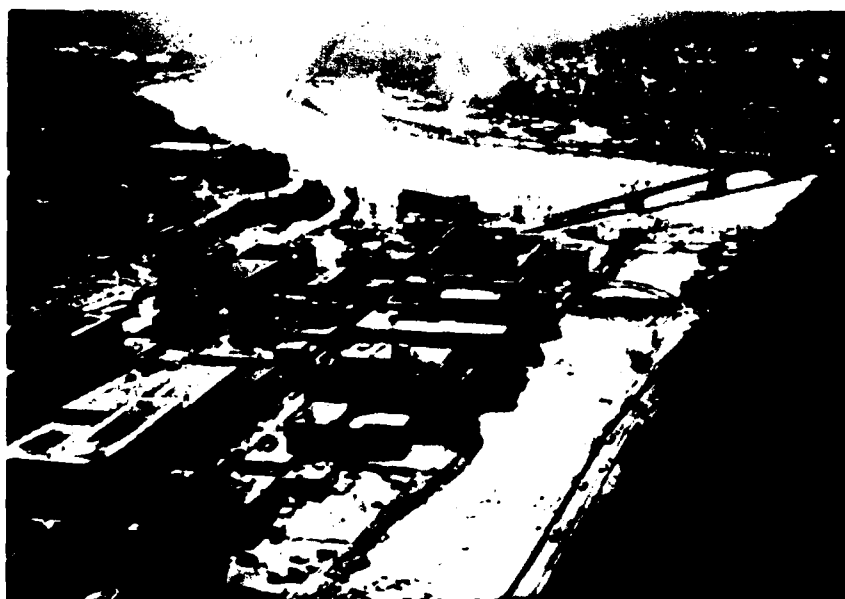
Figure 3. Oil Creek ice jammed at the confluence during breakup.

The Oil City region generally has little snow cover, so the runoff required for a rapid breakup of the ice cover primarily depends on a rainfall of 10 mm or so. Oil Creek responds quickly to this runoff, and its ice breaks up and runs to the river (Fig. 3). The Allegheny River takes much longer to respond, and hence the ice in the Oil City area is still stable at this time. This prevents the creek from discharging its ice. The Oil Creek ice consequently jams and produces overbank flooding. This event has occurred, on average, about every other year since 1950. Some \$4,000,000 in damages resulted from the 1982 flood alone (Fig. 4).

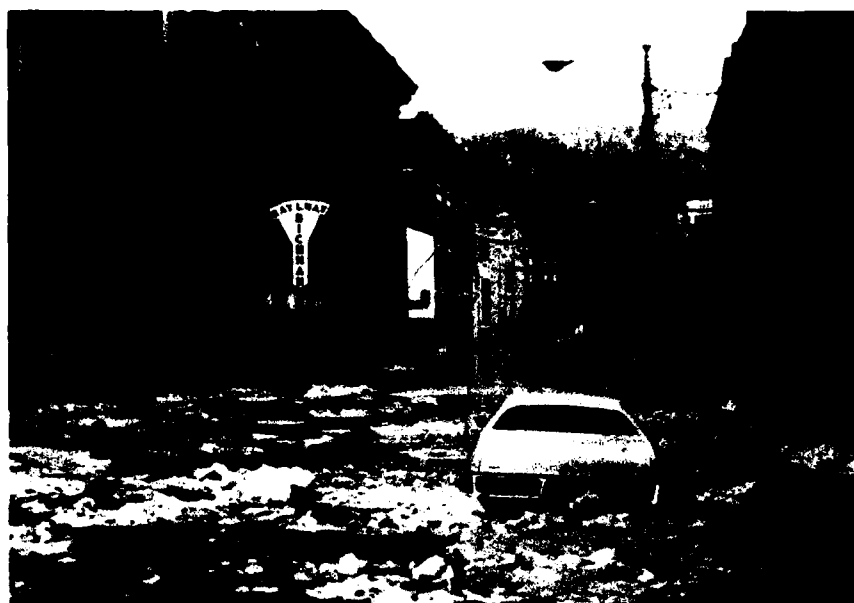
Figure 4. Results of an ice jam.

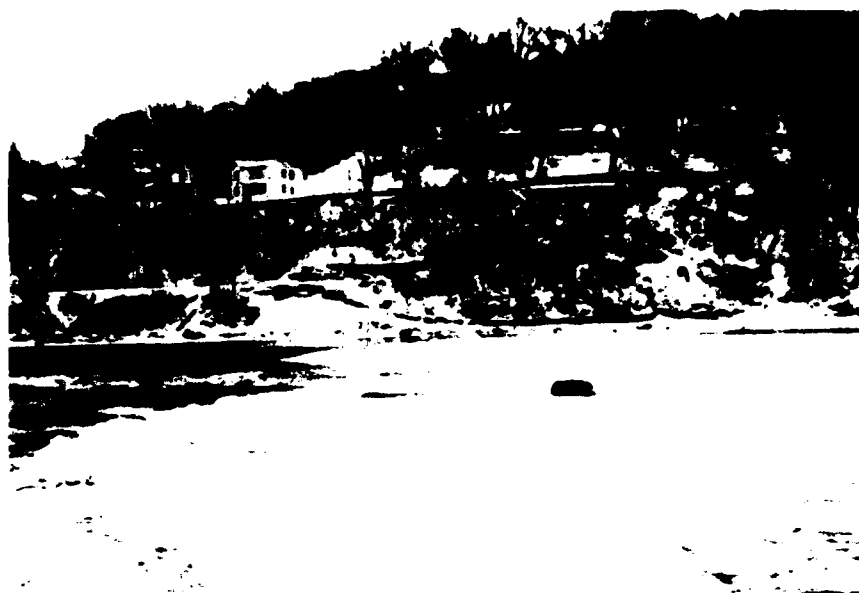
Figure 7. Ice cover formed behind the ice control structure.

From 0700 on, the ice cover formed more as a natural one would. The large number of frazil floes passing through the opening were continually compressed and thickened until they developed enough internal strength to arch or bridge the opening. This occurred at 1300 hrs on the 18th. The cover then grew very quickly upstream over the full 500-m pool (Fig. 7).
